SAND98-2702

Posttest Metallurgical Evaluation Results for Steel Containment Vessel (SCV) High Pressure Test

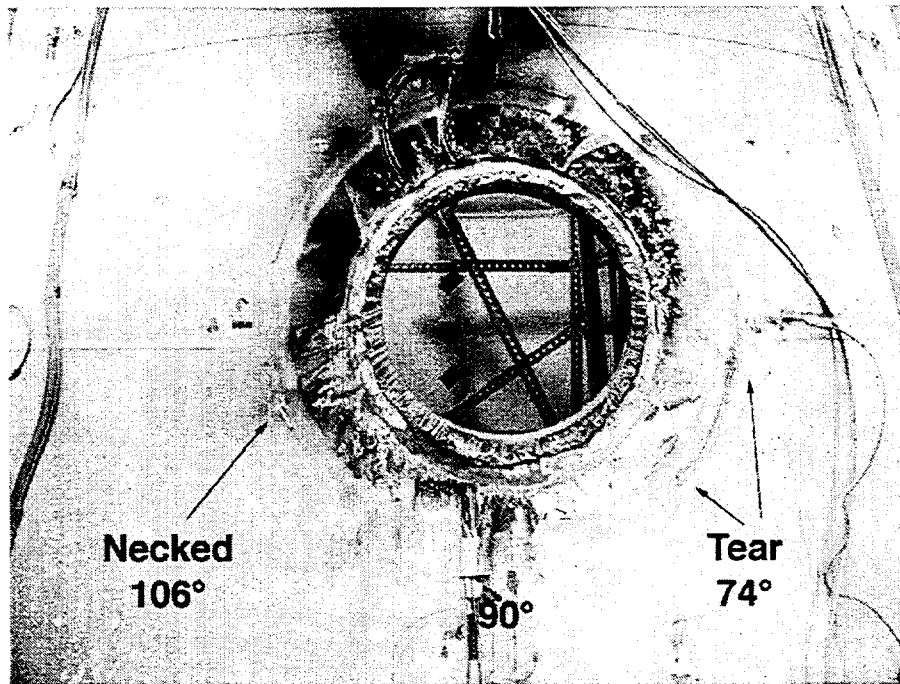
1. At the equipment hatch, a tear formed at the 74° azimuth at the junction of the hatch reinforcement plate and the 9 mm lower conical shell section (LCS) plate material. Symmetrically on the other side of the hatch at the 106° location, a localized neck formed at the similar position (Figure 3-1).
2. Damage occurred at two locations 180° apart, associated with the middle stiffener (MST) ring. A tear formed in the model wall below a weld relief hole in the stiffener ring (Figure 3-2) at position 201°, and a local neck formed in the similar location at 21°.

Figure 3-1. Exterior view of the equipment hatch (after removal of the barrel) showing torn and necked locations.

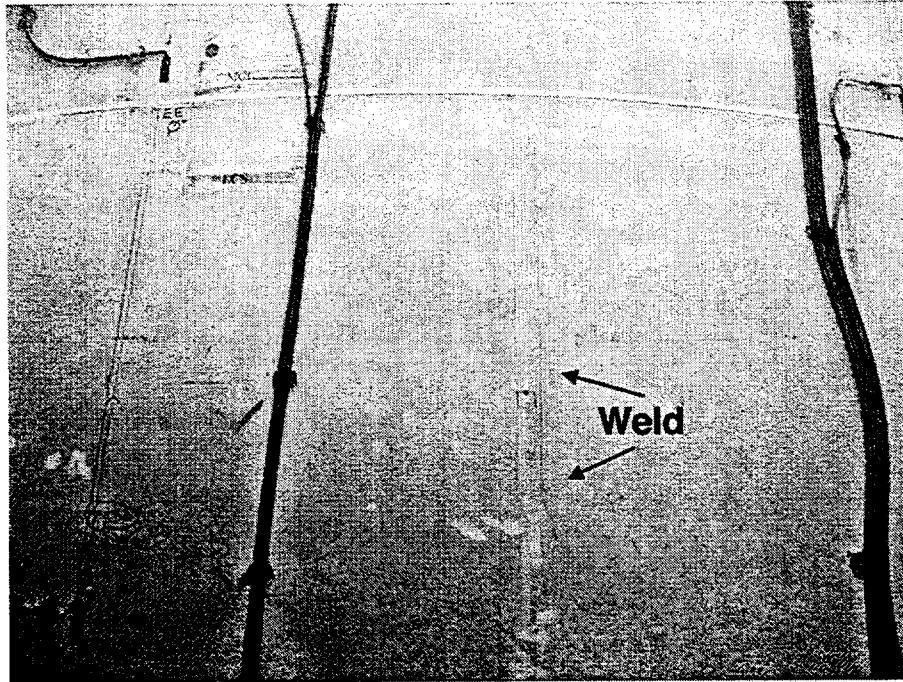
3. Local necks formed within the vertical weld lines at the 160° and 340° positions which connect the two plates forming the LCS (Figure 3-3). These necks and other areas of local deformation on the outer surface of the model are visible because the paint coating is brittle and cracks.

Figure 3-3. Overall external view of necked vertical weld in LCS model section.

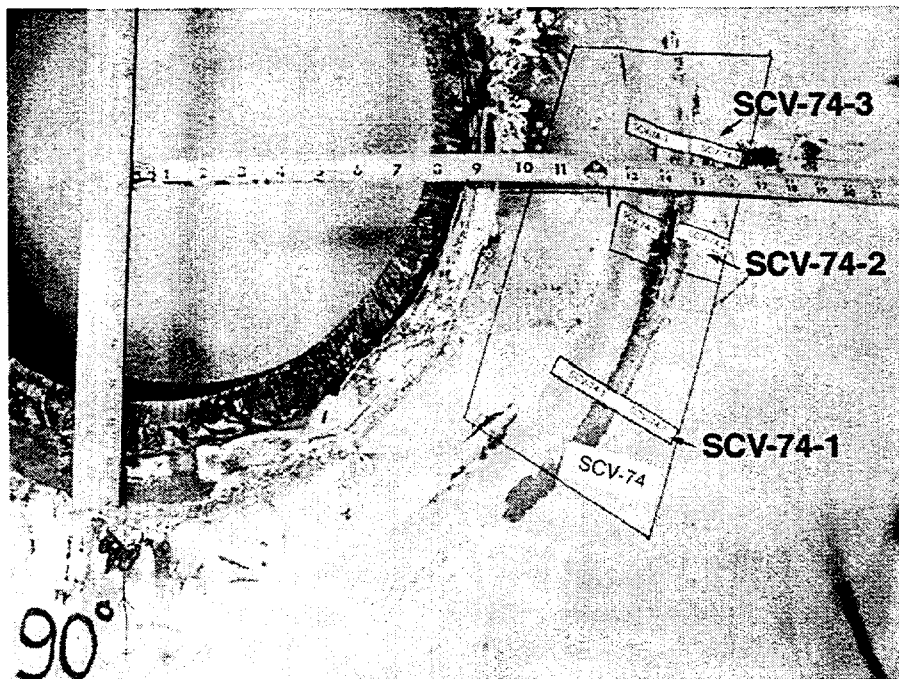
The tear at the 74° position near the equipment hatch was approximately 190 mm long, with an additional several centimeters of localized necking extending from either end of the tear (Figure 3-4). The local deformation is evident from the cracked paint. An interior view of the same tear is shown in Figure 3-5; note the position of strain gages near the tear. Three samples were cut from the area of the tear for metallurgical analysis. These included SCV-74-1 and SCV-74-3, which came from the untorn locally deformed regions on either end of the tear, and were mounted and sectioned to examine the deformation and local microstructures. Sample SCV-74-2 spanned the tear, and its fracture surfaces were analyzed by scanning electron microscopy to determine failure mode.

Figure 3-4. External view of EQH showing tear at 74° and sample locations (ruler marking in inches).

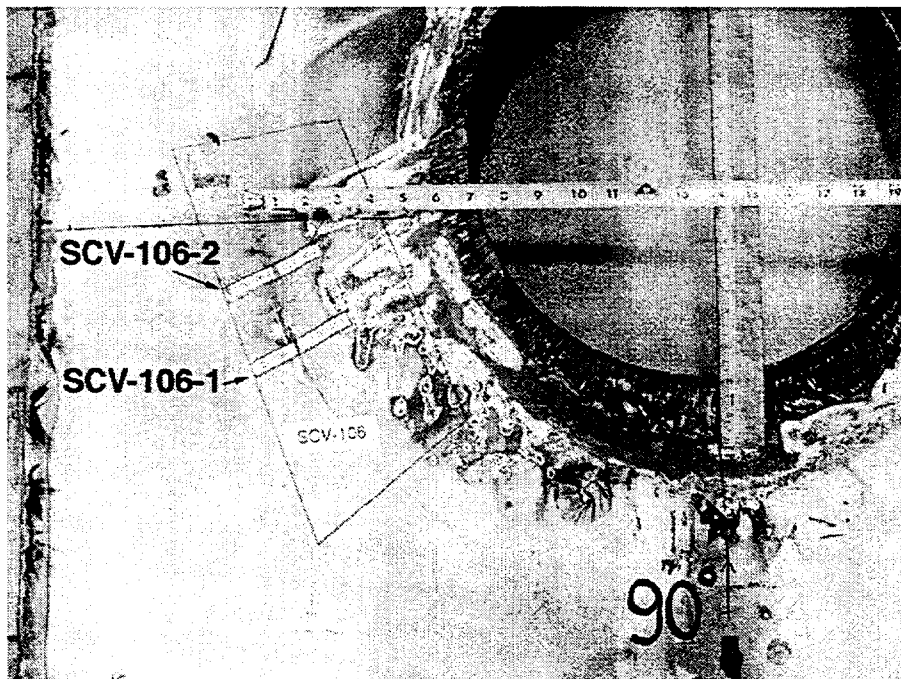
Figure 3-6. External view of EQH showing necked region at 106° and sample locations (ruler markings in inches).

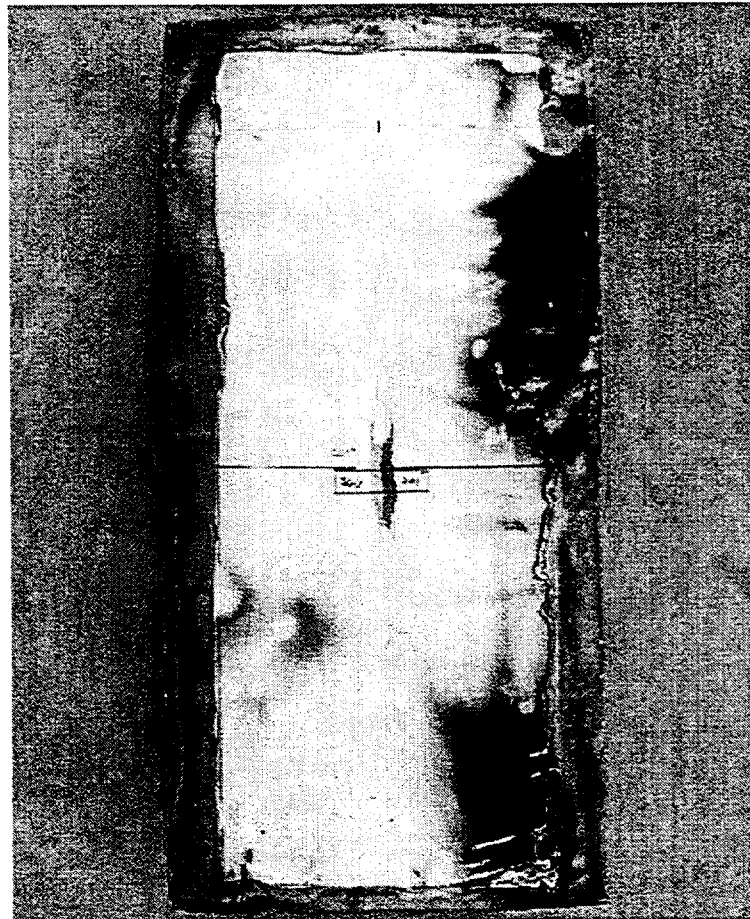
Figure 3-8. External view of tear below MST ring at 201° .

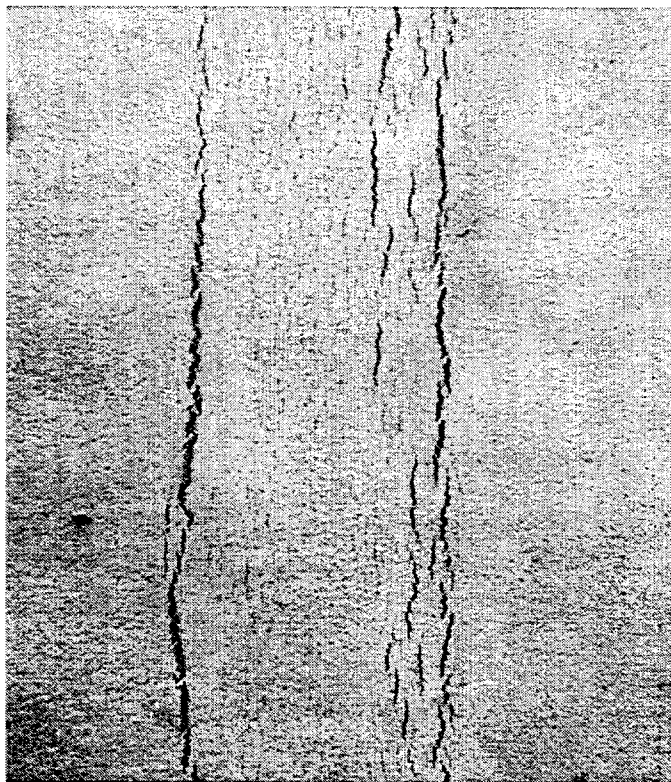
Figure 3-9. Closeup of exterior view of local deformation (causing cracks in paint) at the vertical weld in LCS at 340°.

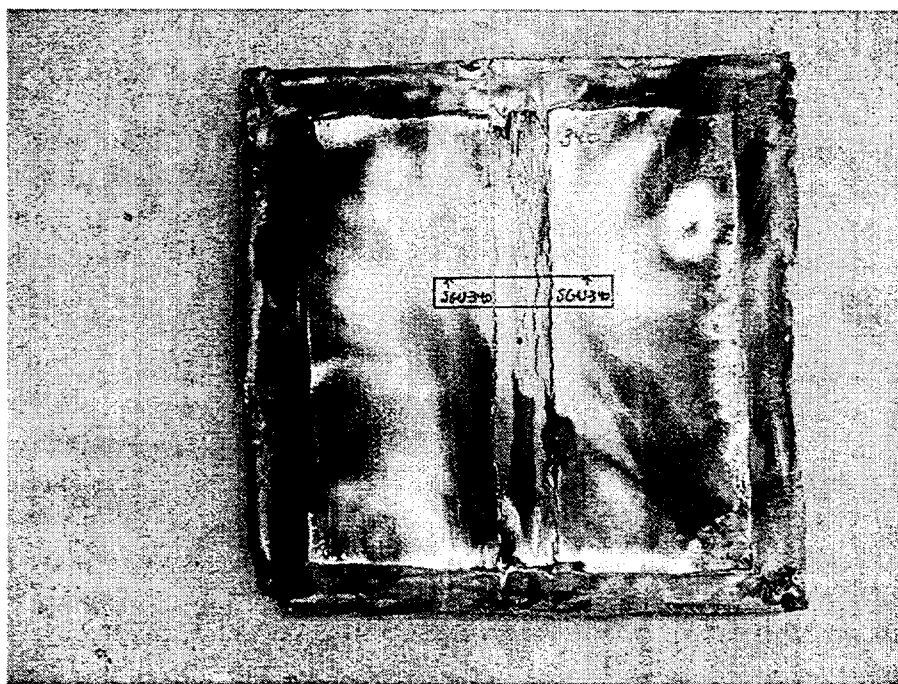
Figure 3-10. Sample SCV-340 taken from vertical weld in LCS at 340° (external view).

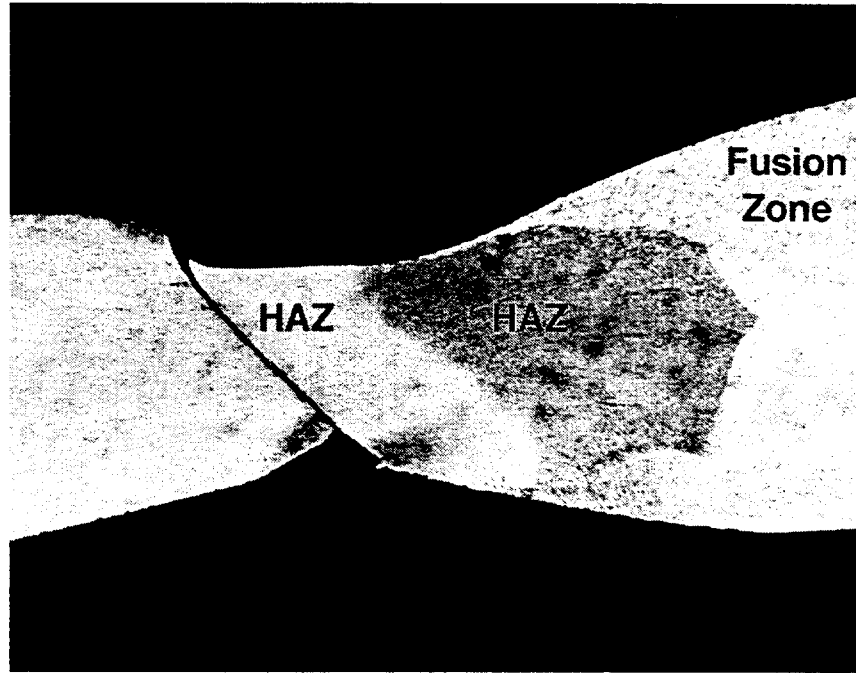
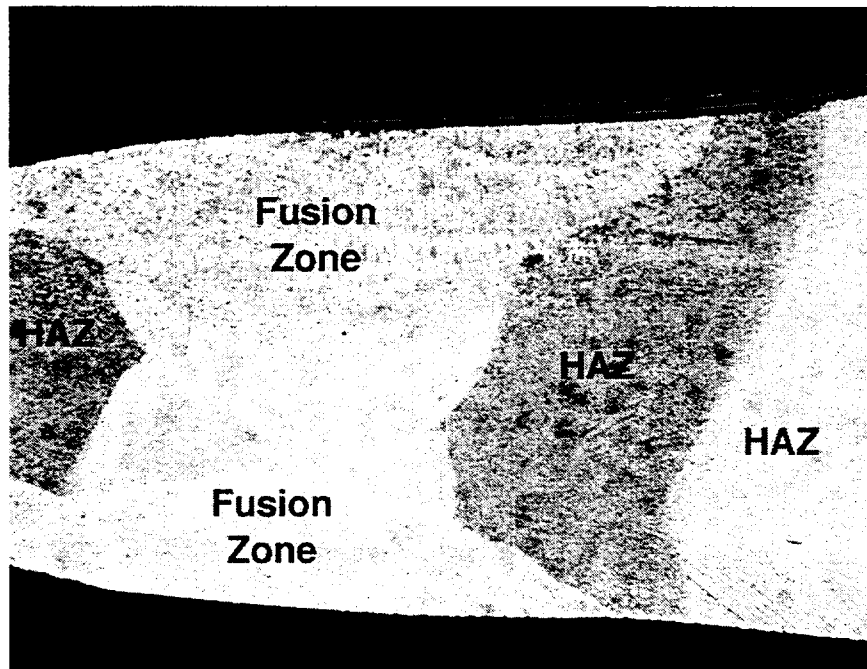
In all cases necking was found to have concentrated in the weld heat affected zone. Eventual failure occurred by ~45-degree shear in these heavily deformed regions. No other flaws or provocative microstructural features were found to be associated with these failures.

Figure 5-1. Sample SCV-74-1 near bottom of tear adjacent to EQH, 5 \times ; (a) shear tear in lower hardness weld HAZ in 9 mm SPV490 wall material, with weld fusion zone on right; (b) view to right of (a) showing fusion zone and weld HAZ into 17.5 mm SPV490 reinforcement plate. Reaustenitized HAZ areas are dark regions on either side of fusion zone.

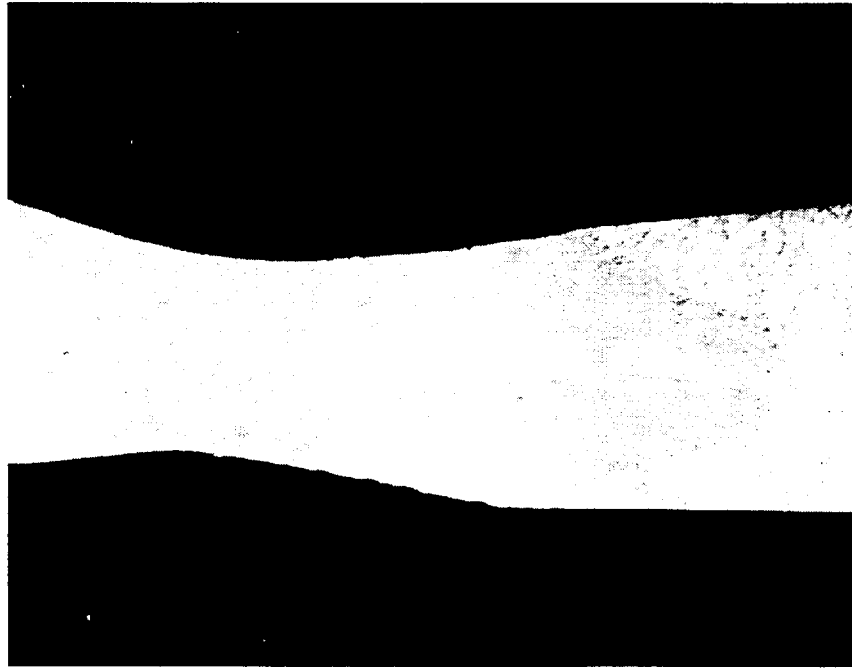
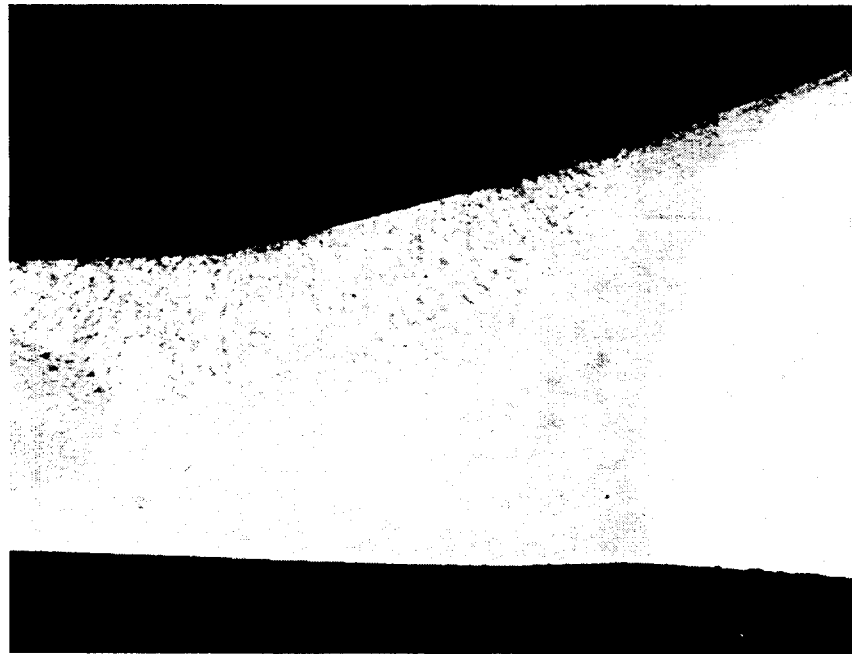
Figure 5-2. Sample SCV-74-3 near top of tear adjacent to EQH, 5 \times ; (a) deformed and necked region in weld HAZ of 8.5 mm SGV480 wall material with weld fusion zone on right; (b) view to right of (a) showing fusion zone and weld HAZ into 17.5 mm SPV490 reinforcement plate.

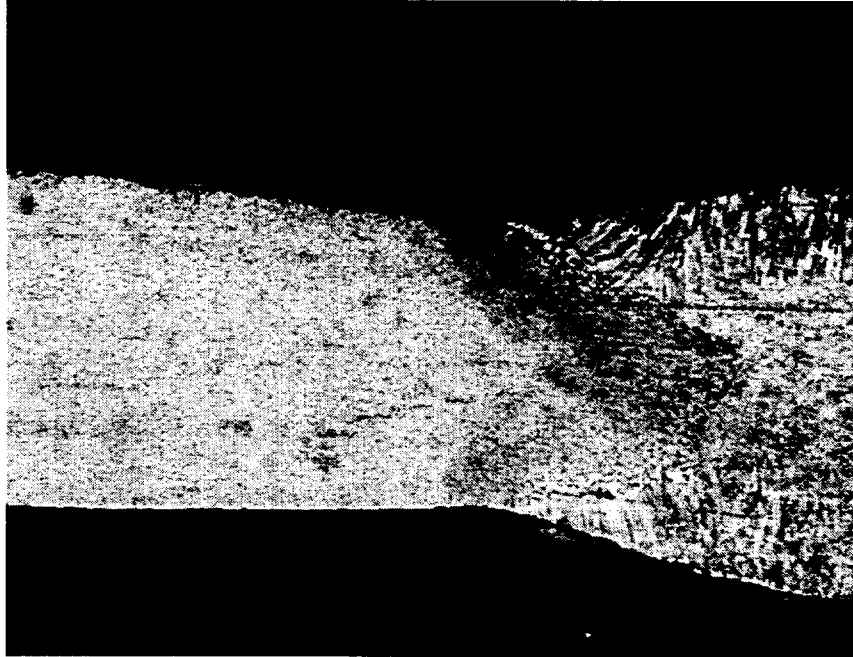
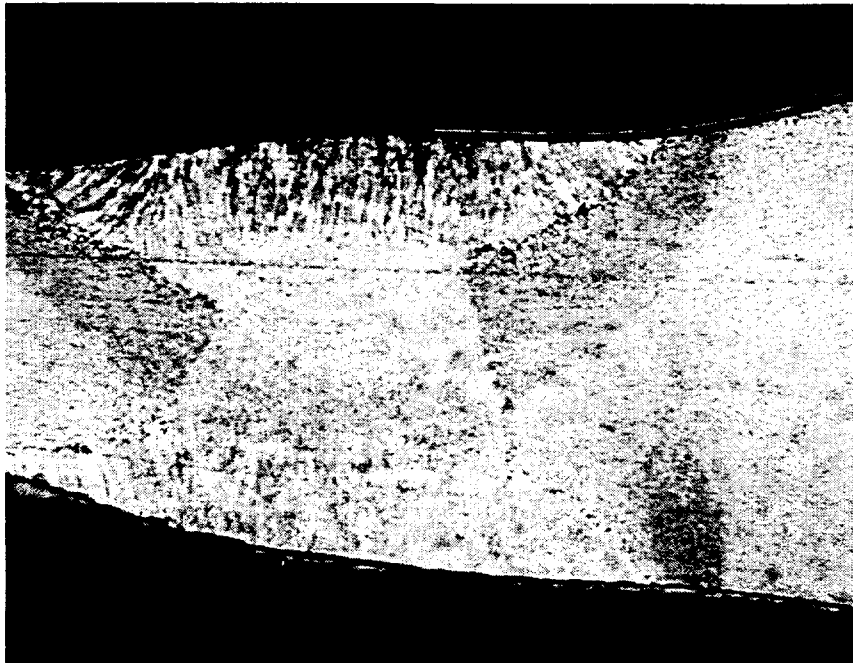
Figure 5-3. Microstructure of necked region at 106° location near EQH, sample SCV-106-1, 5×; (a) thinning deformation in weld HAZ in SPV490 alloy plate with weld fusion zone at right side; (b) view to right of (a) showing weld fusion zone and HAZ of 17.5 mm SPV490 reinforcement plate.

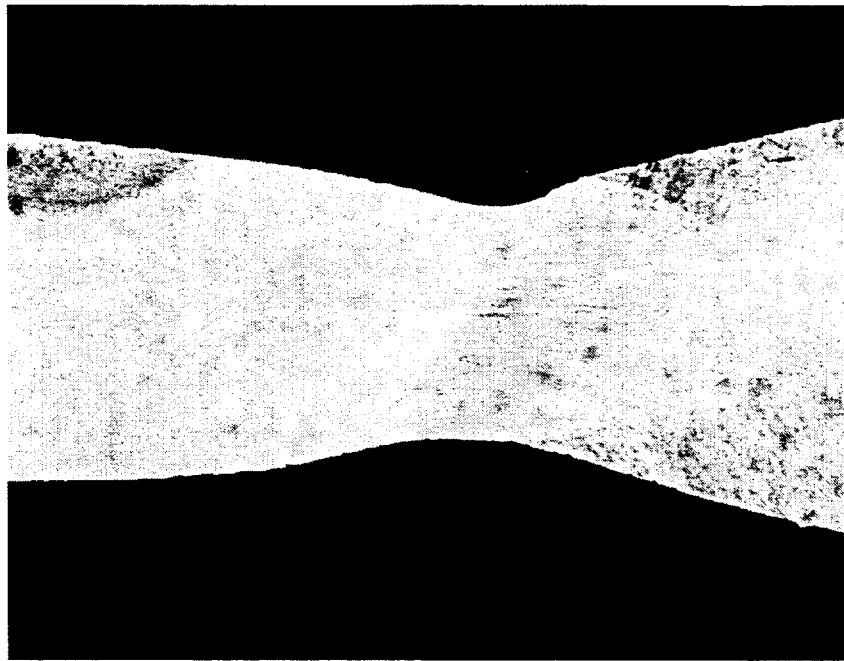
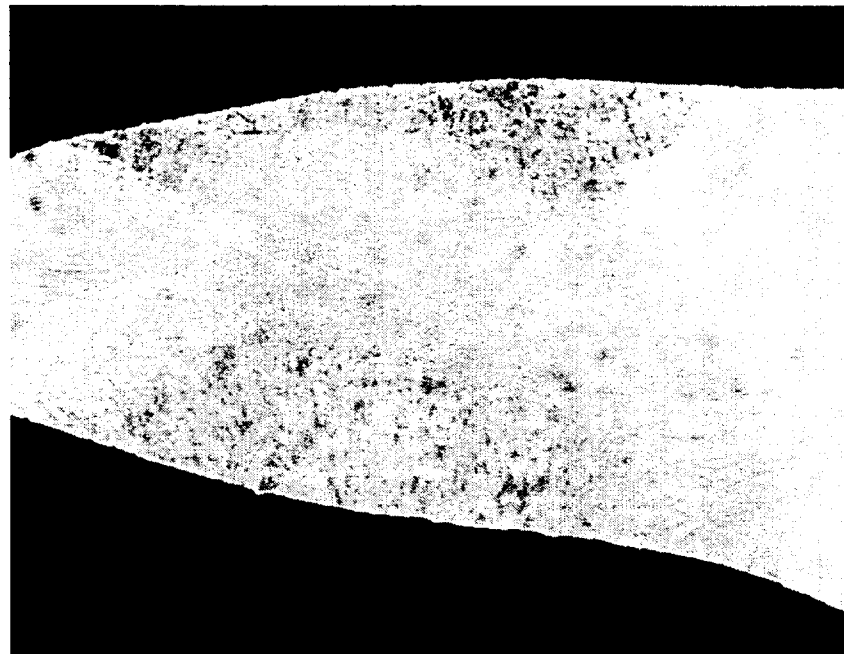
Figure 5-4. Microstructure of necked region at 106° location near EQH, sample SCV-106-2, 5×; (a) thinning deformation at base metal and weld HAZ in SPV490 alloy plate with weld fusion zone at right side; (b) view to right of (a) showing weld fusion zone and HAZ of 17.5 mm SPV490 reinforcement plate.

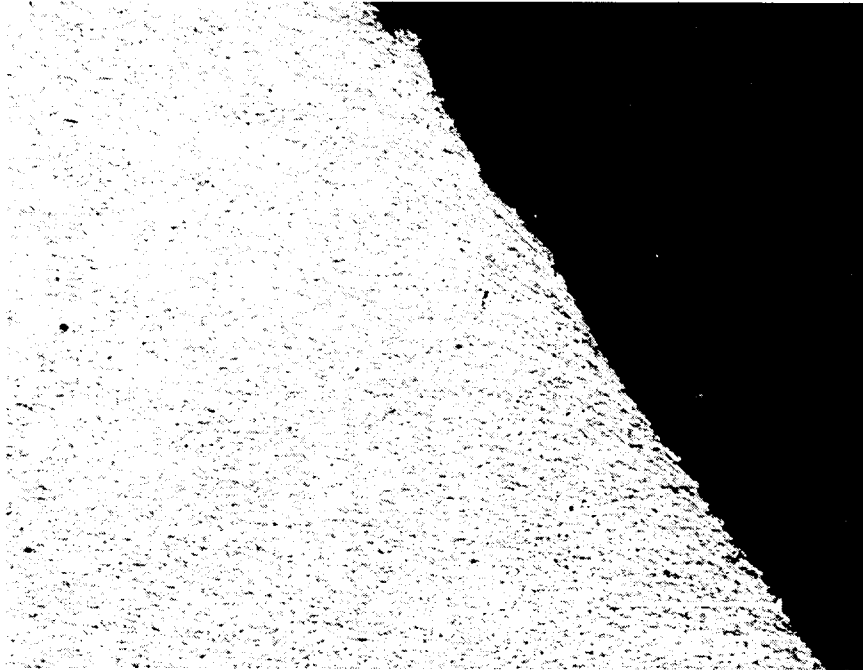
Metallographic examination of samples near the fracture initiation site (SCV-74-2 A, B, and C) revealed evidence of substantial local plastic shear deformation below the fracture surface near the inner and outer plate surfaces (Figure 5-5), but less local shear deformation in the interior of the model wall (Figure 5-6). *This suggests that failure initiated internally within the material, rather than at surface defects.*

Figure 5-5. Local shearing associated in Sample SCV-74-2 with tearing near inner and outer surfaces near tear initiation site, and typical of the entire tear away from the initiation site, 100 \times .

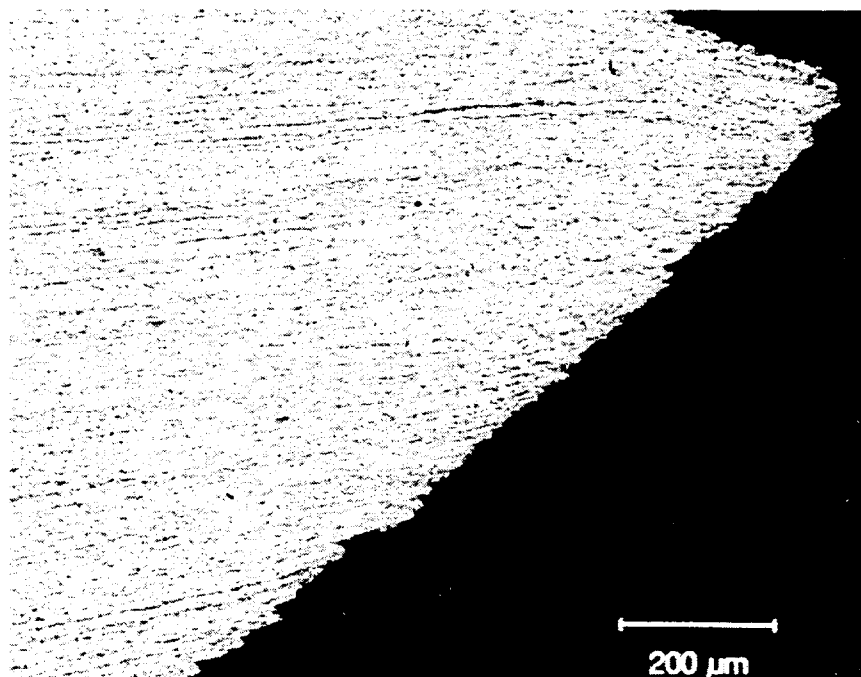
Figure 5-6. Relative absence of local shearing below the fracture surface in the interior of Sample SCV-74-2 denotes the actual fracture initiation site, 100 \times .

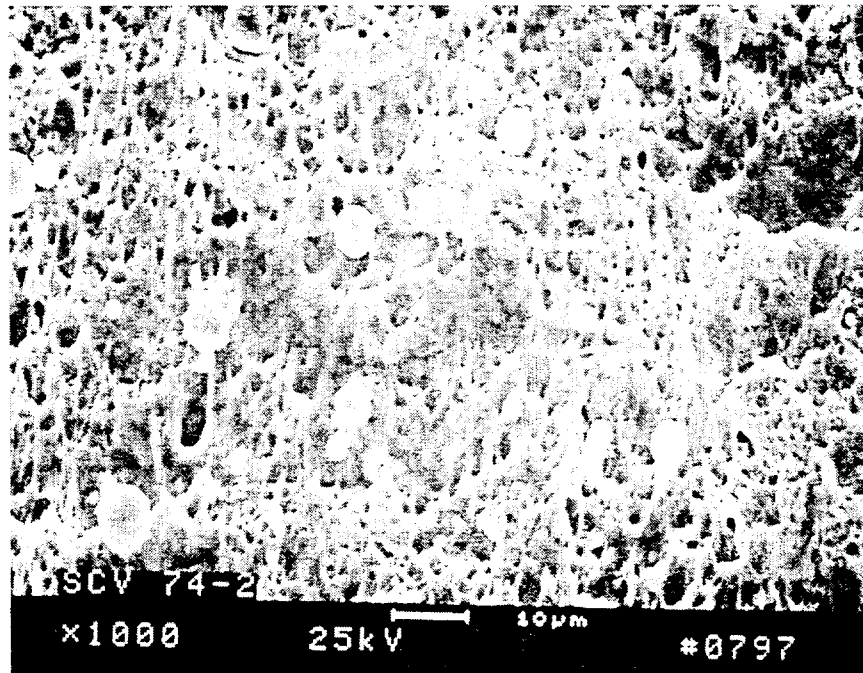
The fracture surface on Sample SCV-74-2 was examined in the scanning electron microscope (SEM) to determine tearing crack growth mode and to check for flaws or initiation sites. *The entire surface of the sample was comprised of ductile shear voids (Figure 5-7) characteristic of ductile shear overload failure.* No surface or subsurface flaws were noted. On these ductile shear void fracture surfaces, it was not possible to locate individual fracture initiation points. The fracture morphology seen here is consistent with ductile overload tearing failure, by shear, after the neck formed.

Figure 5-7. SEM image of ductile shear fracture on tear surface of SCV-74-2 sample taken from tear near EQH (round balls are surface contaminates on the sample).

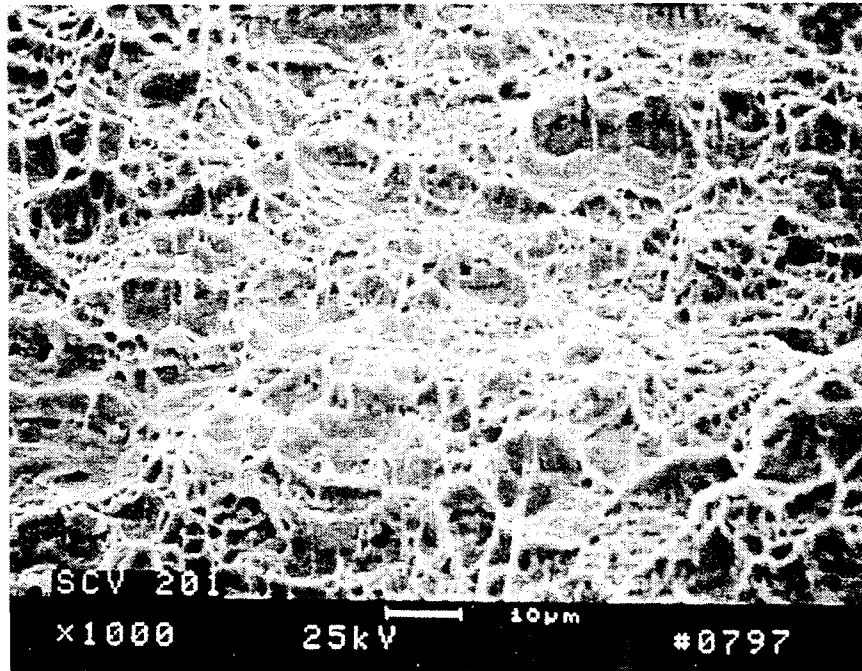
The fracture surface of the tear in Sample SCV-201 was viewed in the SEM to determine the fracture mode (Figure 5-9). This tear formed primarily in shear as a ductile overload failure. The figure shows ductile shear voids on the surface. *No flaws were noted which would have contributed to premature failure.* The measured reduction-in-area measured in the wall adjacent to the stiffener cutout at 201° is shown in Table 5-1.

Figure 5-9. SEM image of ductile shear fracture on tear surface of SCV-201 sample taken from tear in wall below stiffener.

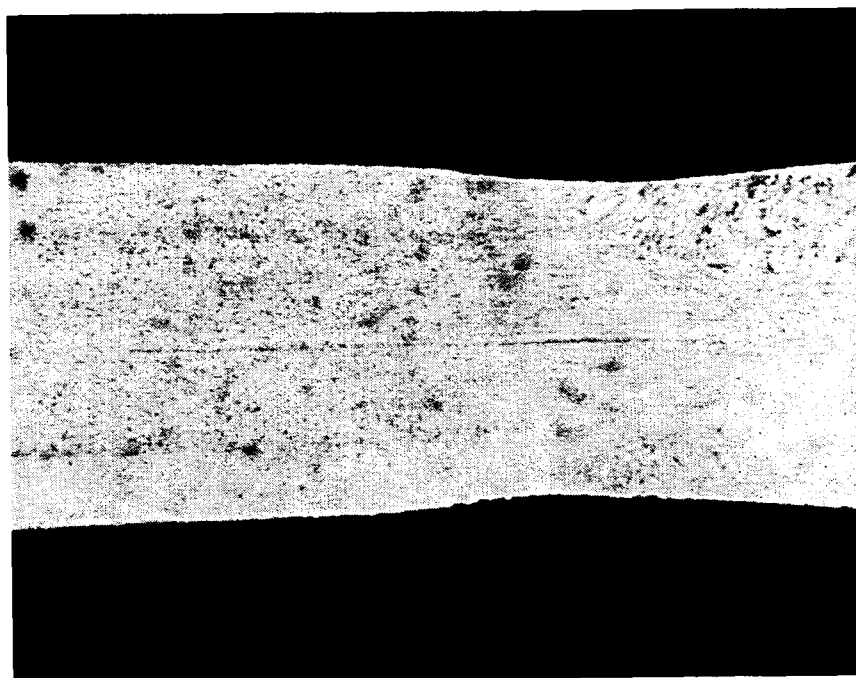
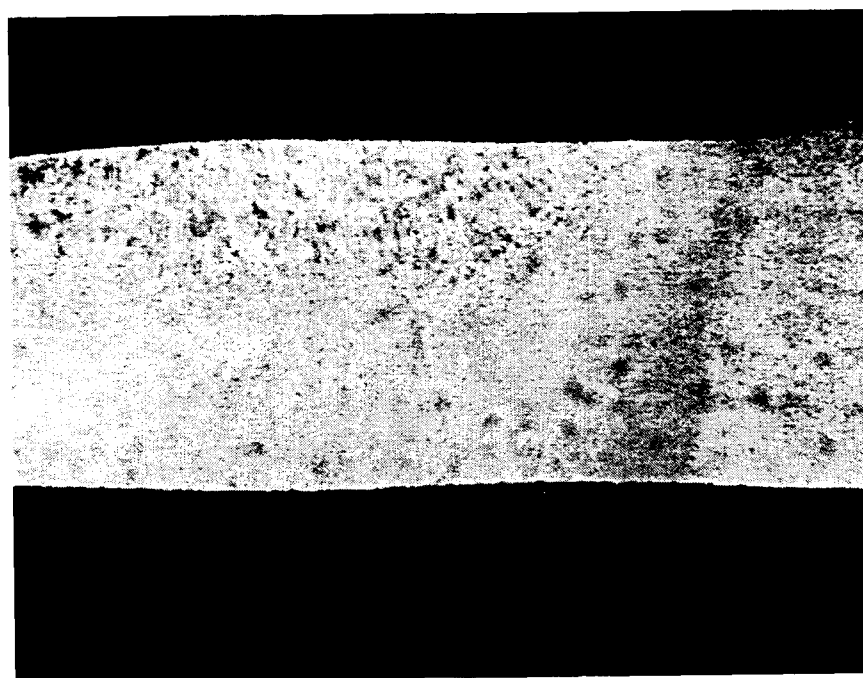
Sample SCV-340 consisted of two sections of 9 mm thick SPV490 welded vertically to one another. The microstructures and hardnesses of the fusion zone, heat affected zones, and base metal were similar to those described previously (Figure 5-10). Deformation was concentrated in the heat affected zones adjacent to each side of the weld, due to the low hardness in these regions. The reductions-in-area measured for each side of the weld are shown in Table 5-1.

Figure 5-10. Cross-section microstructure of vertical weld at 340° between plates of 9 mm SPV490 steel, Sample SCV-340; (a) plate material at left, necked HAZ at center, and weld fusion zone at right; (b) weld area to right of (a) showing, left to right, weld fusion zone, slightly necked HAZ, and 9 mm plate.
